HPS Components Used to Repair Competitor Pumps, Increased Injection Rate by 15%, Saved USD 800,000

Costayaco Field, Colombia

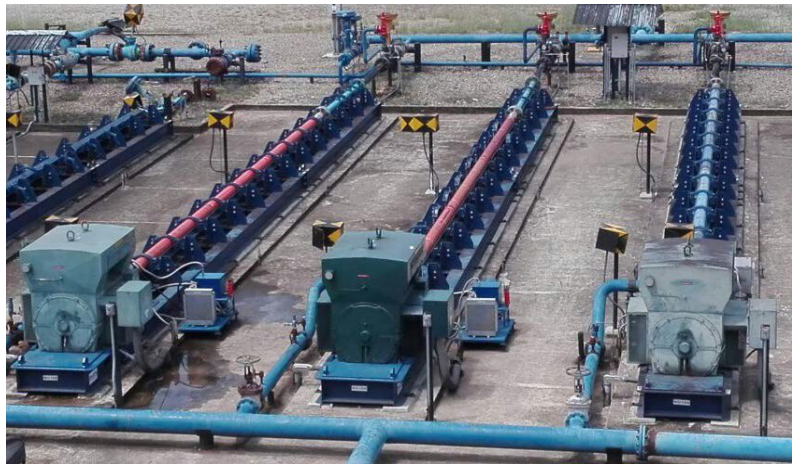
Novomet components used to replace only the failed components in a competitor HPS installation.

Novomet replaced the failed pump sections with our multistage centrifugal pumps capable of handling up to 60% free gas. We also replaced the damaged thrust chambers, added a cooling system to increase runlife, and adjusted the skid, piping, control, and power systems. This solution left the competitor motor, skid, and coupling in place, replacing only the components needed to get the pumps back online. The entire operation was completed in 2 days, putting the water flood operation back on production.
